# Dry Transformer Specification for Photovoltaic Power Plants: Investigation into the K-Factor and the Use of 800VAC Disconnectors

**Abstract-** Although there are several transformer manufacturers in Brazil dedicated to photovoltaic power generation, the connection between inverters with a nominal output voltage of 800VAC and the protection system installed before the step-up transformer is still complex. In this paper, issues related to design, installation and supply of equipment and preventive and corrective maintenance are explored. Operating data is presented for two photovoltaic plants (PV), one has a power of 444kWp and the other 406kWp, which share the same installation design. Both plants experienced faults including, in the worst case, a short circuit followed by a fire caused by the general disconnector. The transformers of 500kVA and K1 factor were assessed after the accidents and showed no faults in the measurements taken at the substations. The installation of disconnect switches with a nominal operating voltage ( $U_e$ ) equal to 690VAC was identified as the cause of the short circuit. The quality of the equipment was investigated and an analysis of the operating t

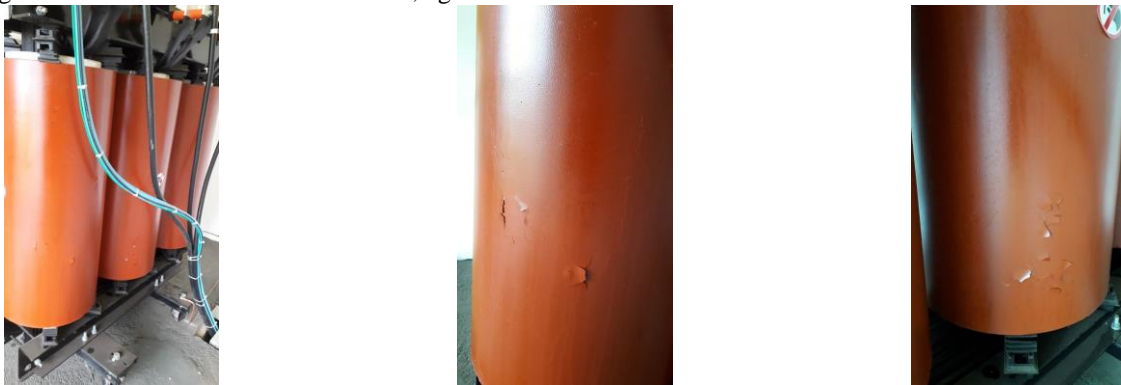
The chronology of the facts is extremely important in order to identify the storage and operating time of each piece of equipment. The 406kWp transformer arrived at the plant on February 17, 2021, from the manufacturer. It was completely installed in the PV substation on March 2, 2021. It was only energized on January 31, 2022, when the temperature measurement error was identified. According to Fig. 1, the damage to the fiberglass seems to indicate that something quite serious has happened to the transformer.

**Fig. 1.** The transformer installed in the substation of the 406kWp photovoltaic plant. As of the date of the image, 04/12/2021, it had not been energized, but already showed degradation of the fiberglass insulation.

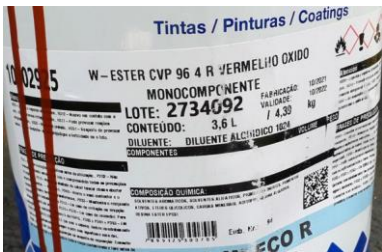
Fig. 2 shows the specification of the paint used by the company responsible for the installation to touch up the peeling paint. No more in-depth repairs or operational analysis

**Fig. 2.** Paint used on 09/03/2022 to repair the transformer's fiberglass. The paint was applied directly to the damaged areas only. 406kWp photovoltaic plant.

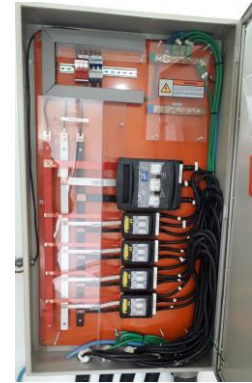
Only the SPDs were reused in the second QGINV shown in Fig. 8. In this new panel, switch-disconnectors were used for the inverters with  $U_e$  of 800VAC,  $I_n$  of 160ACA and  $U_i$  of 1200V, AC-22B load operating capacity, NH000, 100A, 800VAC fuses. For the main switch,  $U_e$  of 690VAC,  $I_n$  of 400ACA,  $U_i$  of 1000V and AC-22B load operating capacity, NH2, 350A, 800VAC fuses were used. The switch manufacturer declined to deliver the main switch because it is only sold commercially with a nominal voltage ( $U_e$ ) of 690VAC and a nominal insulation voltage ( $U_i$ ) of 800VAC, but the design engineers decided to use it. The incorrect installation of the main switch is thought to be the main cause of the accidents at the two PVs.

**Fig. 8.** Internal image of the second inverter switchboard installed on 16/03/2022 at the substation of the 406kWp photovoltaic plant.

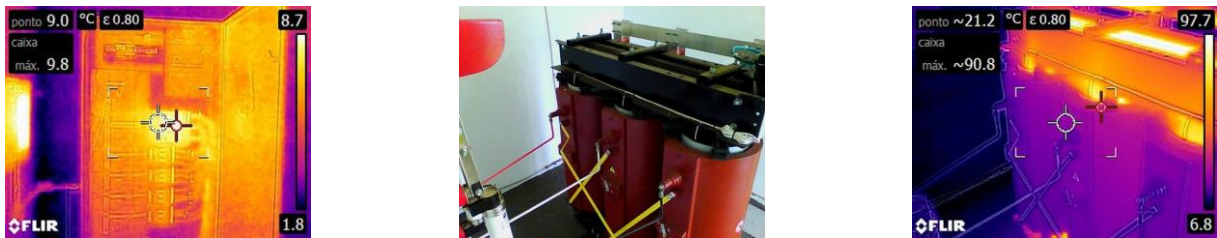
Grids that operate with nominal voltages in the range above 1000V and below 69kV are called medium voltage (MV) distribution systems. The transformer shown in Fig. 9 operates at voltage levels of 13.8kVAC with a medium voltage connection to the distribution network and at 800VAC, which is the nominal voltage of the inverters. With this information and for technical reasons, it is understood that any professional who is going to work in low voltage (LV) should have full knowledge of ABNT NBR 5410 [21] - Low Voltage Electrical Installations: in the case of components with no moving parts, such as fuses, conductors, busbars, rails, channels, connectors, terminals, transformers, etc., the general condition should be inspected, checking for signs of heating and drying out, as well as fixing, identification and cleaning. NOTE: The connections must be retightened no more than 90 days after the electrical installation is put into operation and repeated at regular intervals. NR 10 [22] - Safety in Electrical Installations and Services states that: the project description must contain at least the following safety items: g) a description of the compatibility of the protection devices with the electrical

**Fig. 9.** Thermography of the QGINV on 19/05/2022 at 16h and 30 min in the 406kWp plant. Thermal image of the transformer on the same date and time. The ambient temperature on the same date and time was 12.5°C (at the weather station installed near the substation).

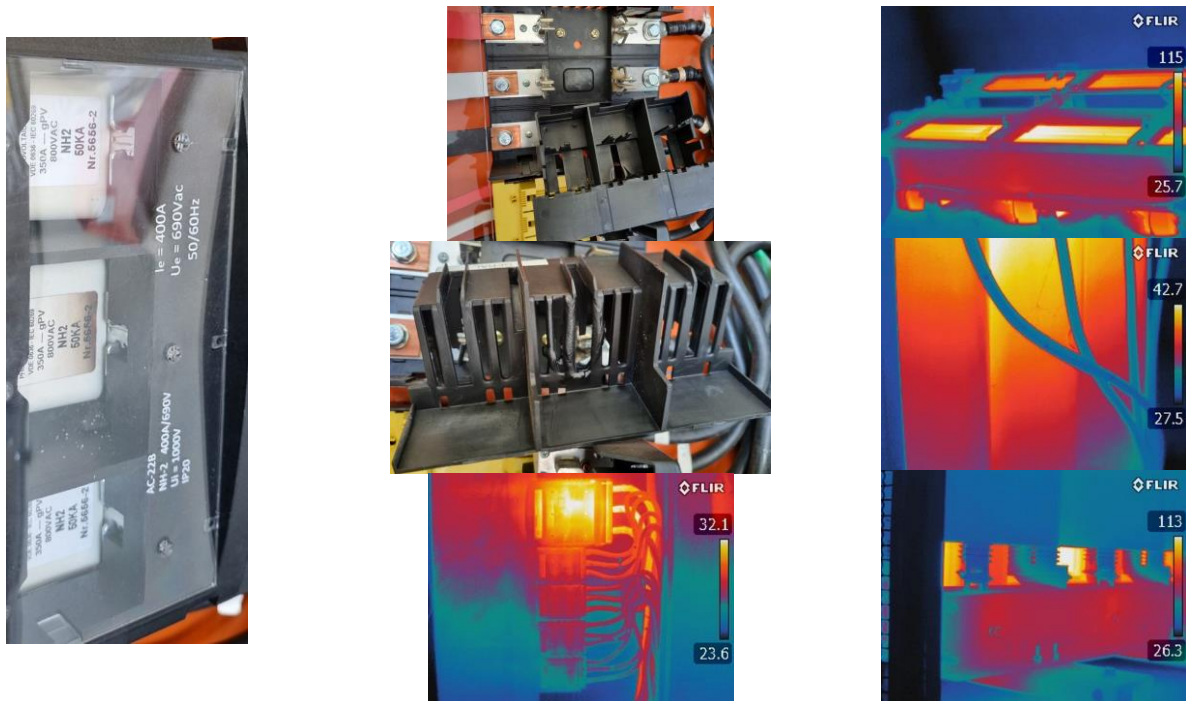
**Fig. 10.** On 29/04/2023, at 6pm, the 406kWp plant was disconnected from the grid. Fuse coloured differently from the others in the general disconnecter. Record of the start of melting of the general disconnecter on the white busbar. Thermography of the top, middle and bottom of the transformer on the same date and time. The ambient temperature on the same date and time was 21.3°C (at the weather station installed near the substation).

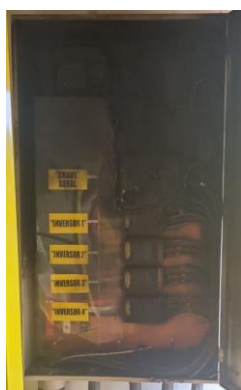
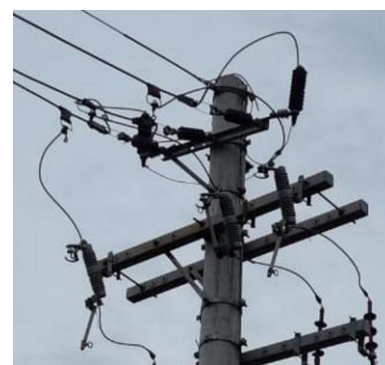
The degree of severity of the short-circuit that was avoided at the 406kWp PV, but which occurred at the 444kWp PV (Fig. 11) can be measured indirectly by the number of faults indicated by the photovoltaic inverters. There are 4 inverters in each plant, all of the same model and power. Maintenance is a common and simple activity, which should be carried out using the plant's monitoring and diagnostics software (in this case, dedicated software called FusionSolar).

**Fig. 11.** On 02/05/2023, the main switch installed in the 444kWp photovoltaic plant caused a short circuit followed by a fire in the plant's substation. One of the fuse links did not break, leaving the three-phase circuit energized after the incident.

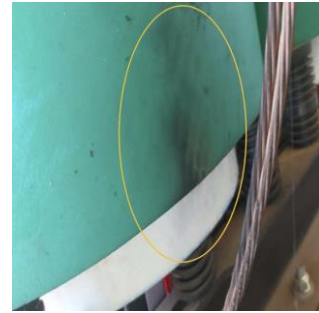
**Fig. 15.** Dark spot on low-voltage insulation. Partial discharge. 444kWp plant.
