# Dry Transformer Specification for Photovoltaic Power Plants: Investigation into the K-Factor and the Use of 800VAC Disconnectors

**Abstract-** Although there are several transformer manufacturers in Brazil dedicated to photovoltaic power generation, the connection between inverters with a nominal output voltage of 800VAC and the protection system installed before the step-up transformer is still complex. In this paper, issues related to design, installation and supply of equipment and preventive and corrective maintenance are explored. Operating data is presented for two photovoltaic plants (PV), one has a power of 444kWp and the other 406kWp, which share the same installation design. Both plants experienced faults including, in the worst case, a short circuit followed by a fire caused by the general disconnector. The transformers of 500kVA and K1 factor were assessed after the accidents and showed no faults in the measurements taken at the substations. The installation of disconnect switches with a nominal operating voltage ( $U_e$ ) equal to 690VAC was identified as the cause of the short circuit. The quality of the equipment was investigated and an analysis of the operating t

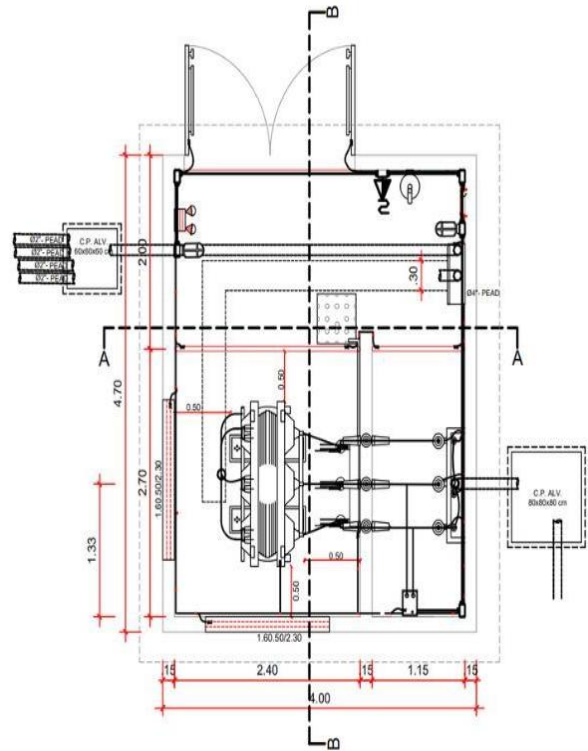
Fig. 16 and 17 shows the floor plan of the substations built at the 406kWp and 444kWp plants. The design complies with the transformer manufacturer's requirements: 0.5m between the transformer and the walls. The two 1.6m wide by 0.5m high openings are located 1.8m off the ground. This configuration does not meet the basic installation requirement: cold air inlet at the bottom of the transformer and outlet located at the top.

**Fig. 16.** Floor plan of the substations built in the 406kWp and 444kWp plants.

Based on the results obtained, the need to increase the cooling capacity of the substation's internal environment was identified. As a result of this analysis, another possible source of failure was identified. The general switch-disconnector that caused the accidents was housed inside a metal frame 1.2m high, 0.8m wide and 0.35m deep, completely closed. According to the manufacturer of the disconnect switches, TES690-02, THS and TES800-00, THS, the maximum working temperature is +55°C. This method of installation has certainly reduced the useful life of the switches. Exhaust fans must be installed on the door of the inverter control panel (QGINV).

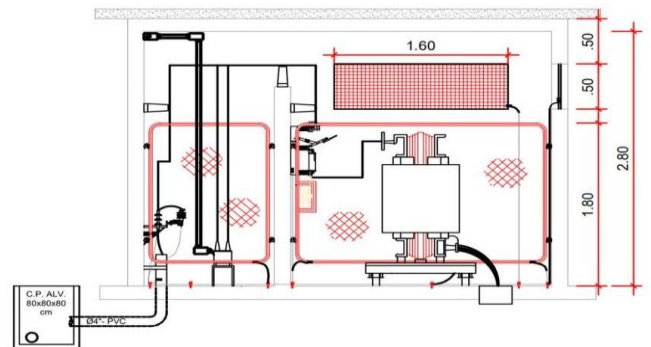
**Fig. 17.** Section AA of the floor plan of the substations built at the 406kWp and 444kWp plants.
